Navajo Abandoned Uranium Mine

Site Screen Report

CBW-MC AUM Site

August 2010

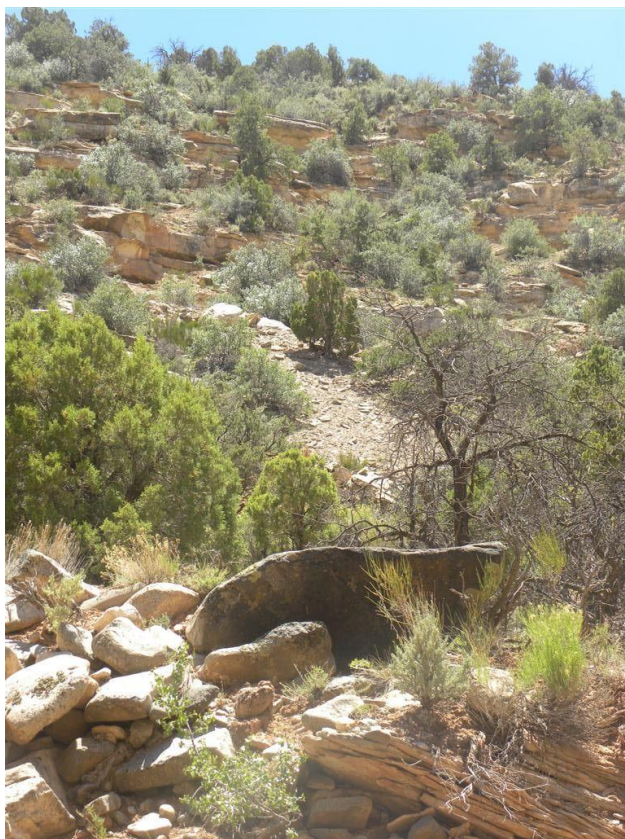
Photo 1. CBW-MC site

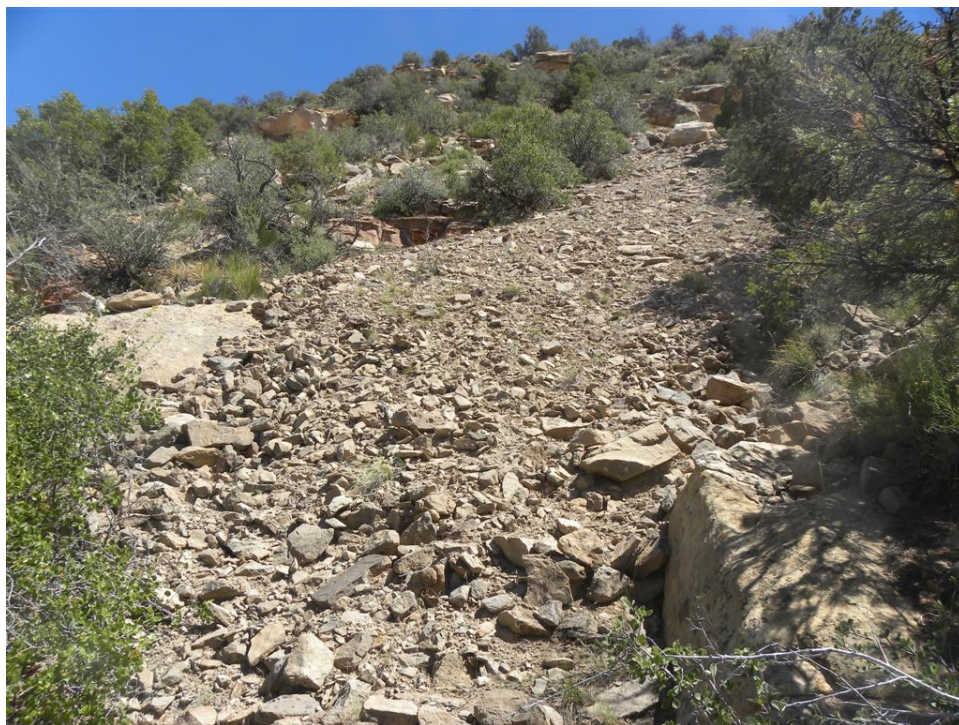
Waste debris extending to drainages from adits, 100' x 80' x 1.5'

Photo 2. CBW-MC site, waste rock

2 sealed adits; unreclaimed waste rock

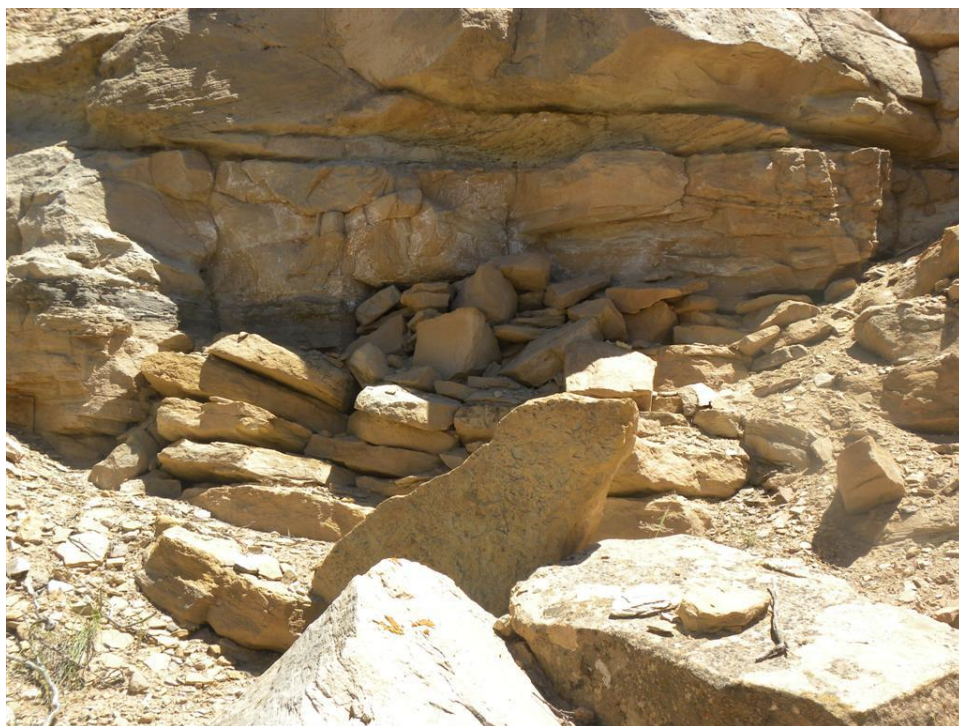
2 stone sealed adits: adit 1 12' x 6', adit 2 10' x 5'

Photo 3. CBW-MC site, sealed adit 1

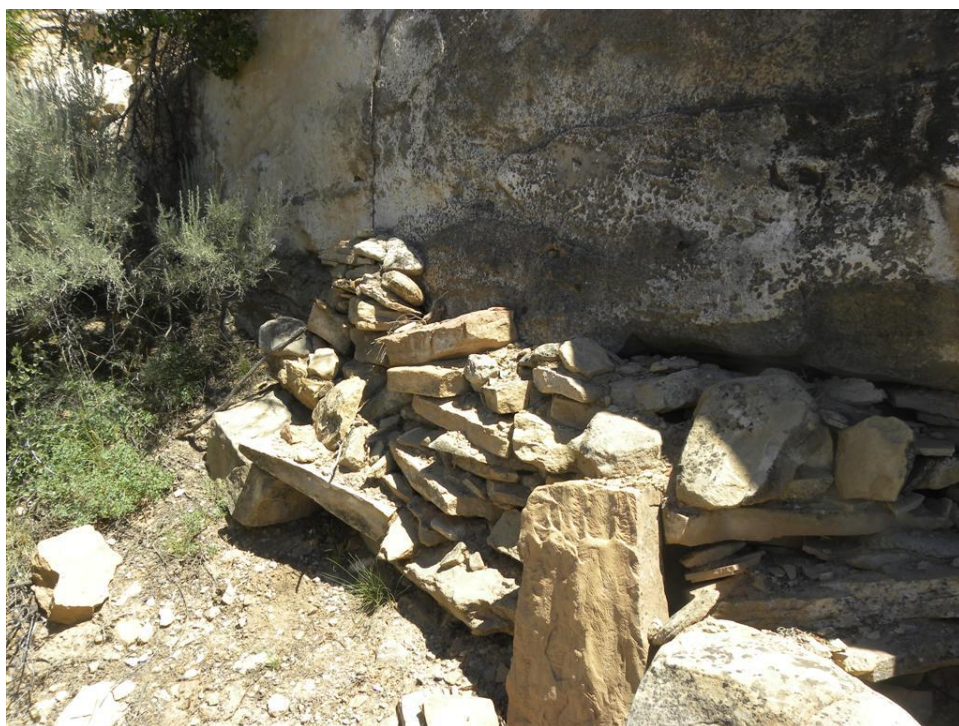
Photo 4. CBW-MC site, sealed adit 2
